INCIDENT — TANK DAMAGE, KRIEGER HALL (MAY 2014)

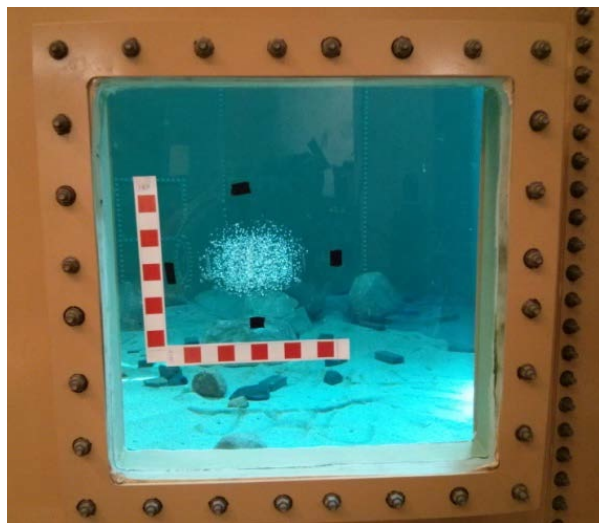
While performing experiments in a large water tank, a researcher placed an incandescent spotlight in front of a 2-inch thick Plexiglas observation window. During the experiments, the lamp slipped and came to rest against the window surface. The window melted one-third of the way through, compromising its mechanical integrity.

Fortunately, the window had been oversized—three times the vendor's recommended thickness. The researcher discovered the damage before the tank leaked and flooded the basement floor of Krieger.

- When placing temporary equipment in lab, make sure it is safely positioned and secured.
- When specifying equipment to a vendor, consider overdesigning structural components if there is a risk of failure or damage and the consequences would be serious.
